Article

Setup of Galvanic Sensors for the Monitoring of Gilded Bronzes

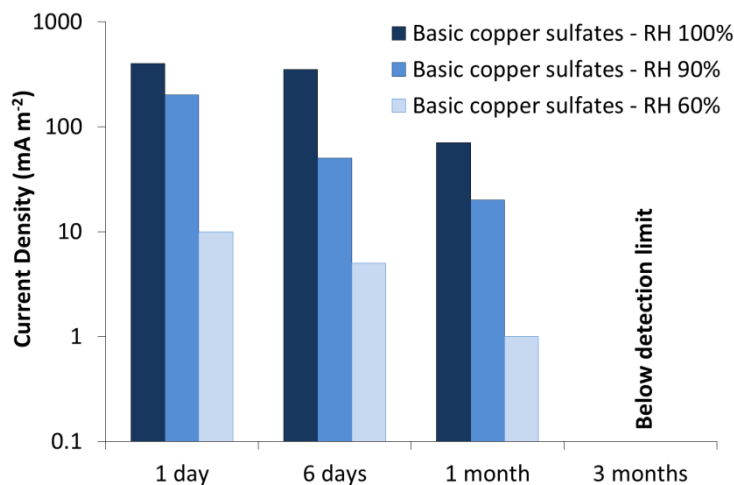
Figure 1. The galvanic sensors of the seventies [48,49]: macrocouple current as a function of time and relative humidity.

The first galvanic sensors simulating gilded bronzes were designed during the seventies to evaluate new conservation strategies for Lorenzo Ghiberti's *Porta del Paradiso* [48,49]. At that time the possibility to maintain the *Porta del Paradiso* in its original location was under discussion and the first sensors were therefore designed to operate in outdoor conditions under high relative humidity values: up to 100% RH with the presence of superficial moisture [48–50]. The metallic substrate of the sensors was a quaternary bronze (83.90% Cu, 5.80% Sn, 4.25% Pb, 5.30% Zn, 0.58% Ni), and the artificial patina of corrosion products was mainly constituted by basic copper sulfates. The gilding was obtained by applying a thin gold sheet glued along the lateral edges of the sensor. The maximum current density was reached during the first 24 h and for 100% RH (Figure 1). The current density then decreased quickly with time, falling below the detection limit after three months. Those sensors therefore could only be used to monitor gilded bronzes for a short time period and in quite humid conditions ($\text{RH} \geq 60\%$).

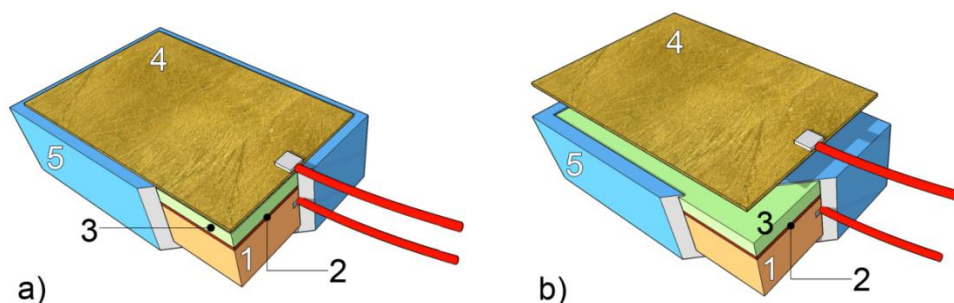
Figure 2. General model of a galvanic sensor (a) with detail of the gold leaf overlapped (b). The complete stratigraphy of the sensor includes: (1) metallic substrate; (2) cuprite layer; (3) patina of corrosion products; (4) gilding; (5) electric insulation cover.

The scheme and a picture of the galvanic sensors setup used in the present study are given in Figure 2.

Pure copper (Cu 99.90%) and a quaternary bronze alloy, (Cu 93,1%; Zn 3,2%; Sn 2,6%; Pb 1,1%) have been used as metallic substrates for the realization of the galvanic sensors. The stratigraphy of the sensors can be described as follows: (1) metallic substrate; (2) cuprite layer (Cu_2O); (3) artificial patina of corrosion products; and (4) gilding.

Each sensor has electrical connections both to the metallic substrate and to the gilding for the measurement of the macrocouple current: the connection to the substrate is obtained by a metal rivet, while the gold leaf is connected by means of conductive silver-based glue applied on its external surface. The lateral sides, the back and all the connections of the sensor are coated with epoxy resin in order to ensure the electrical insulation of the entire system.

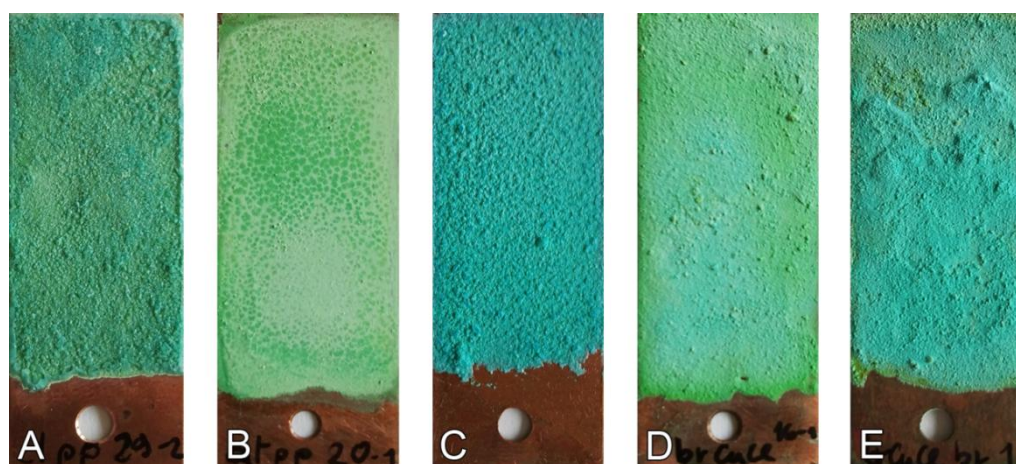
Figure 3. Photographic documentation of the different types of patina: S&C (A); BCC (B); BrocChal (C); BrocNan (D); BrocNan+Broc (E) (specimens dimensions: 60 × 20 mm).

Prior to the preparation of the sensors, the copper substrates have just been degreased in acetone, while the quaternary bronze substrates were milled in order to remove all the undesired corrosion products. This way, a homogeneous surface has been achieved. The cuprite layer is obtained after a 30–60 min immersion of the metallic substrate in a boiling solution containing: (a) 25 g/L copper sulfate for bronze, and (b) 6.5 g/L copper sulfate, 1.25 g/L copper acetate, 2 g/L sodium chloride and 1.25 g/L potassium nitrate for copper [45]. The cuprite layer could enhance the adhesion of the corrosion products to the sensor substrate and its efficiency is currently under evaluation. This layer should therefore be considered as optional with respect to the overall stratigraphy. Tests have been conducted on sensors with and without the cuprite layer; however the results presented here always refer to a complete stratigraphy, thus including the cuprite layer. The artificial patina of corrosion products has been prepared according to the “applied paste” method described by Hughes and Rowe [45]: copper compounds (selected according to the type of patina, see details in Table 1) are finely grounded in a mortar; water is added until a paste with adequate fluidity is obtained; the paste is then finally spread on the metallic surface by means of a stainless steel spatula. The “applied paste” method allows the preparation of artificial patinas with a wide range of different compositions, which are representative of the various conservation conditions of ancient gilded bronzes. Moreover, the thickness of the artificial patinas can be tuned by overlapping additional layers (up to three overlapped layers have been tested), having either a similar or a different mutual composition. The thickness has been verified by using a micrometric gauge. The characteristics and recipes of the artificial patinas which have been set up for the preparation of the galvanic sensor are summarized in Table 1. The types of patina to be reproduced and tested in the present study have been selected according to their relevance in the conservation of gilded bronze artifacts, as reported in the scientific literature [28,29,31,51–53]. All patinas have been used for the preparation of both copper and bronze sensors. Photographic documentation of the obtained patinas is shown in Figure 3.

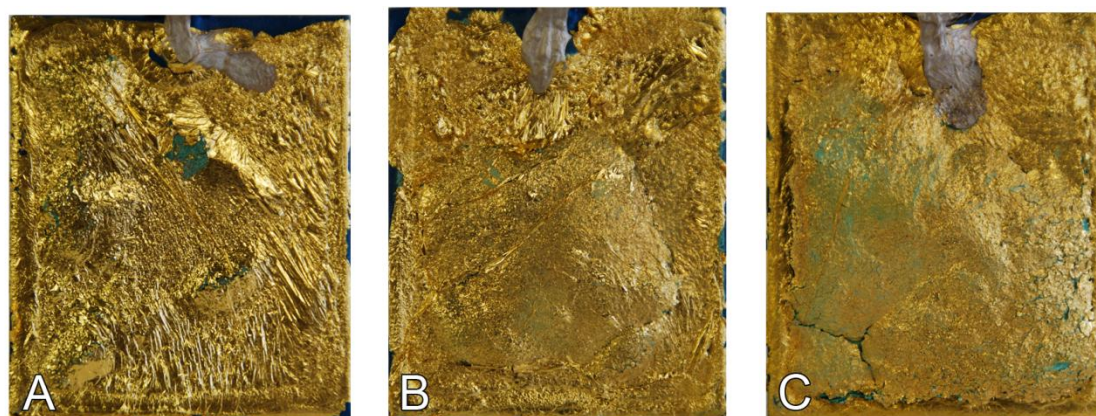
Figure 4. Photographic documentation of galvanic sensors with increasing thickness of the patina realized on copper substrate and with a S&C patina: single layer (A), double layer (B) and triple layer (C) (sensors dimensions: 60 × 50 mm).

On the one hand, the patina should be thick enough to avoid short circuits between the gilding and the metallic substrate. On the other hand as the thickness of the patina increases, the overall durability of the sensors tends to be reduced. This phenomenon is mainly associated to the presence of hygroscopic compounds (e.g., chlorides) within the patina, that tend to blister and to detach from the metallic substrate as a result of the volume change triggered by relative humidity variations. As it can be observed in Figure 4, after few months under laboratory conditions and variable RH (10%–70%), the S&C single layer shows limited blistering and gilding detachment and is much more stable and durable compared to the double and triple layer. The latter sensor, in particular, completely degrades showing an almost complete detachment of the artificial patina.

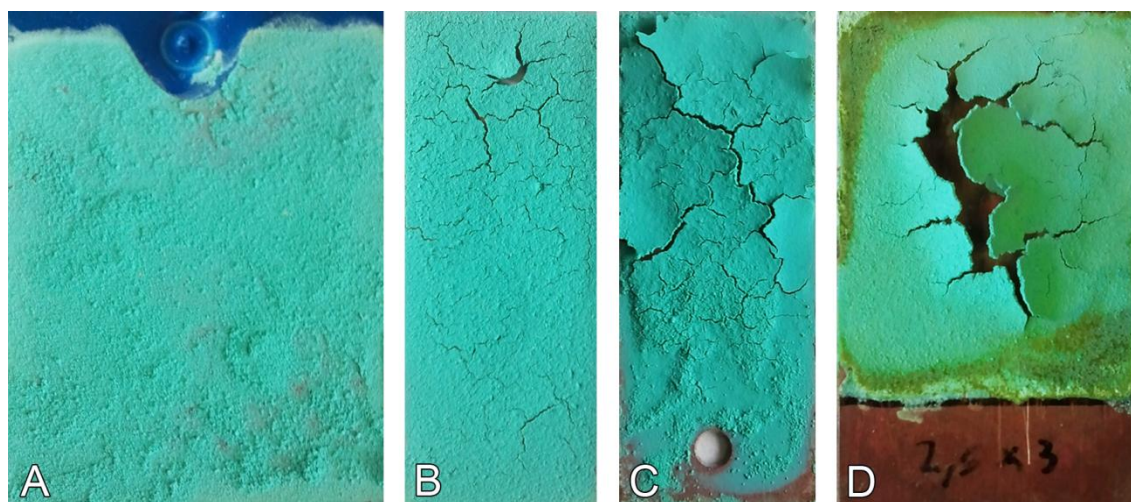
Figure 5. Brochantite patinas with increasing thickness (A) > (B) > (C) > (D) (sensors max. length: 60 mm).

brochantite patina is to apply a very thin paste (Figure 5A), which however shows scarce cohesion and a rather powder-like aspect. Moreover, such a patina has a very high risk of short circuits between the gold and the metallic substrate.

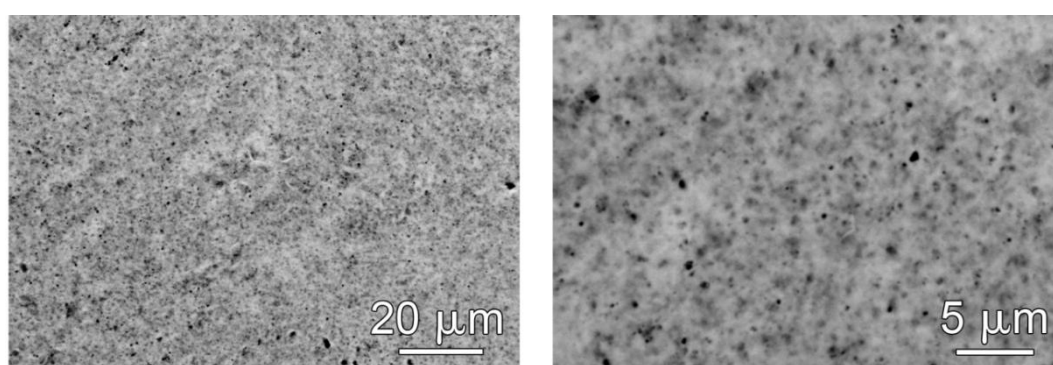
Figure 6. SEM documentation of the characteristic porosity of the gold leaf.

The timing for the application of the gilding is the key factor of this methodology. As previously discussed, the humid nature of the patina enhances the adherence to the metal substrates. Nevertheless, a too high moisture content of the patina can promote migration of soluble salts through the porosity of the gold leaf, thus causing surface crystallization. In Figure 6 the characteristic porosity of the gold leaf is reported. As it can be observed, the porosity is not homogeneous and the maximum pore diameter is generally below 1 μm . Figure 7 shows the typical aspect of a sensor in which the gold leaf has been applied too early on a very humid patina.

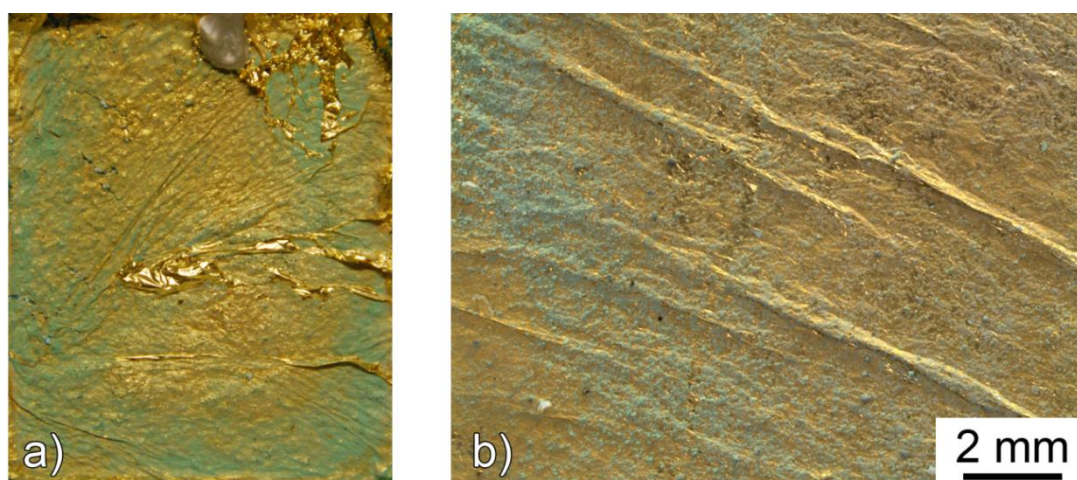
Figure 7. Macroscopic (sensor dimensions: 60 \times 50 mm) (a) and microscopic (b) documentation of a galvanic sensors resulting from the too early application of the gold leaf on a highly moistened patina.

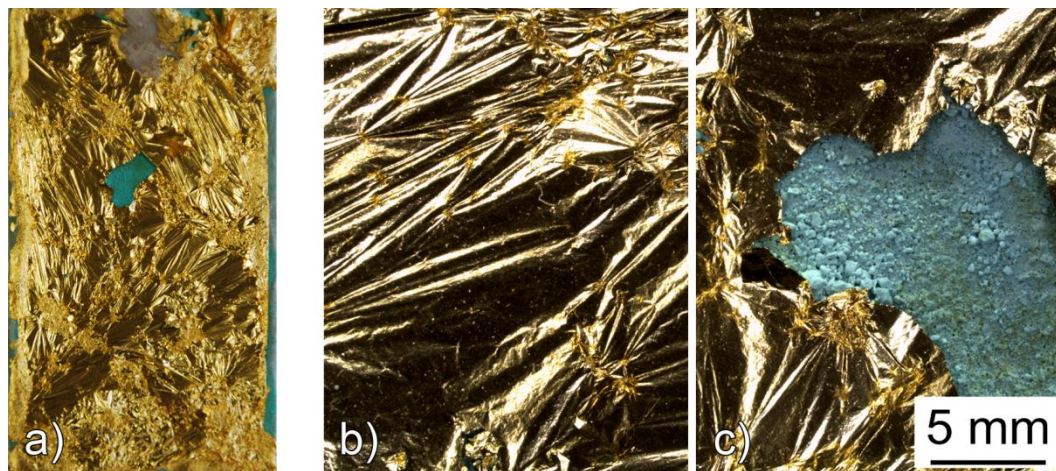
Figure 8. Macroscopic (sensors max. length: 60 mm) (a) and microscopic documentation (b,c) of a galvanic sensors showing a lack of adhesion of the gold leaf.

On the other hand, the application of the gold leaf on a too dry patina will determine a limited adhesion to the substrate, as shown in Figure 8.

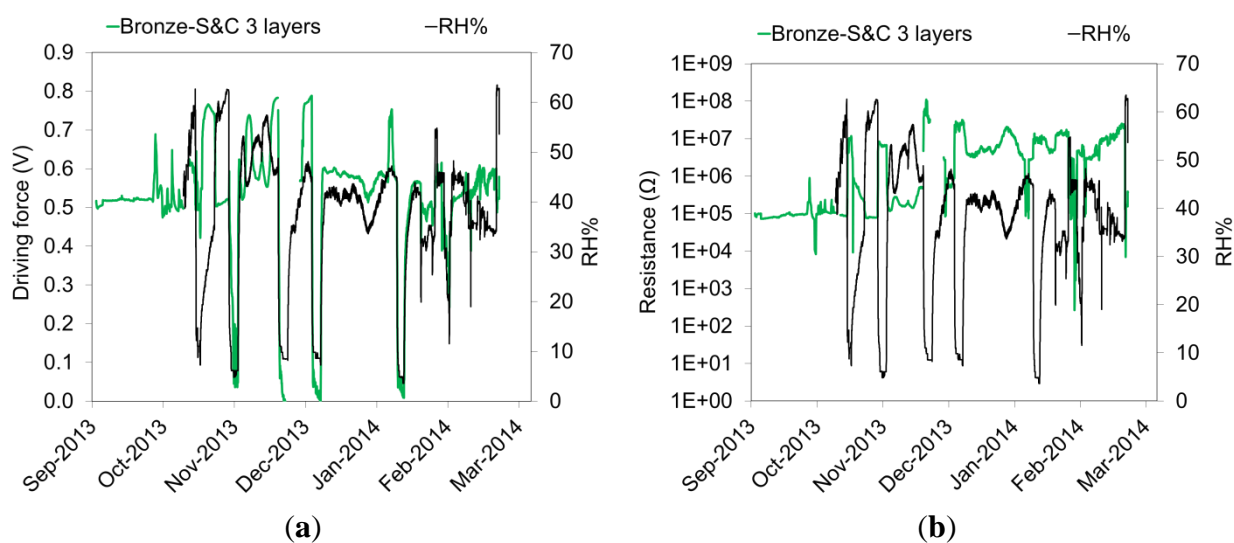
Figure 10. Driving force (a) and Resistance (b) as a function of time a galvanic sensors with bronze substrate and triple layer of S&C artificial patina.

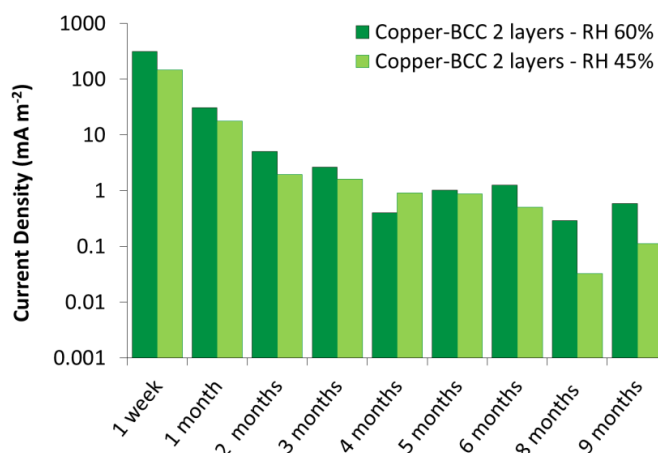
Figure 11. Average macrocouple current density detected at constant temperature (25 °C) and relative humidity (60% and 45%) for galvanic sensors with copper substrate and double layer of BCC artificial patina.

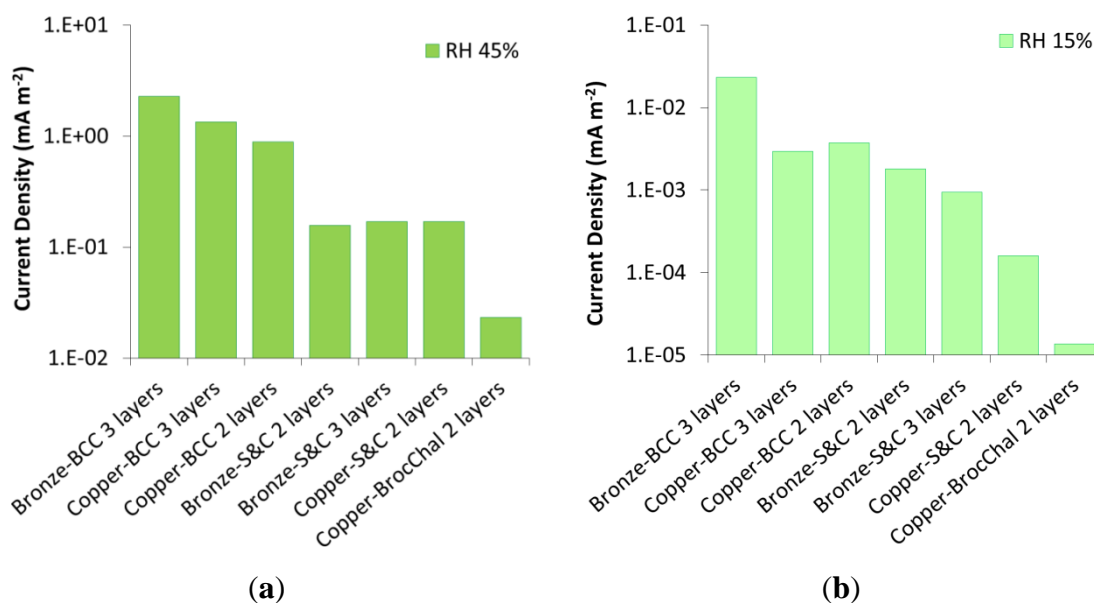
Figure 12. Average macrocouple current density as a function of the artificial patina composition and thickness, detected at constant temperature (25 °C) during the fifth month of life of the galvanic sensors at RH% 45% (a) and 15% (b).

As it can be observed in Figure 12, there are no significant differences in terms of macrocouple current between sensors realized on copper or bronze substrate. The slightly higher macrocouple current density observed for the bronze substrates has been mainly ascribed to their rougher surface before the application of the artificial patina that could have guaranteed a better adhesion. This aspect requires further investigation.

The composition of the artificial patina plays a very important role. Variations of almost one order of magnitude have been observed as a result of different compositions of the patina; being the basic copper chlorides the ones with the highest corrosion rates. Therefore, the design of the most suitable
