Supplementary Fig. 1.
Cryoinjury damages endothelial cells of blood vessels, resulting in the interrupted blood supply in the fin.
(A-C) Live-imaging of the vasculature in the *Tg(tie2:GFP)* fish. (A) Brighthfield imaging of the original fin at 10 mpci, 6 hpci and 48 hpci. Cryoinjury plane is indicated with the blue line.
(B-C) Fluorescence imaging of the framed areas shown in the upper images respective the color code. Scale bar in (A) = 1 mm, in (B) = 100 μ m.

Supplementary Fig. 2.

Damage of the mature osteoblasts along the cryoinjury plane.

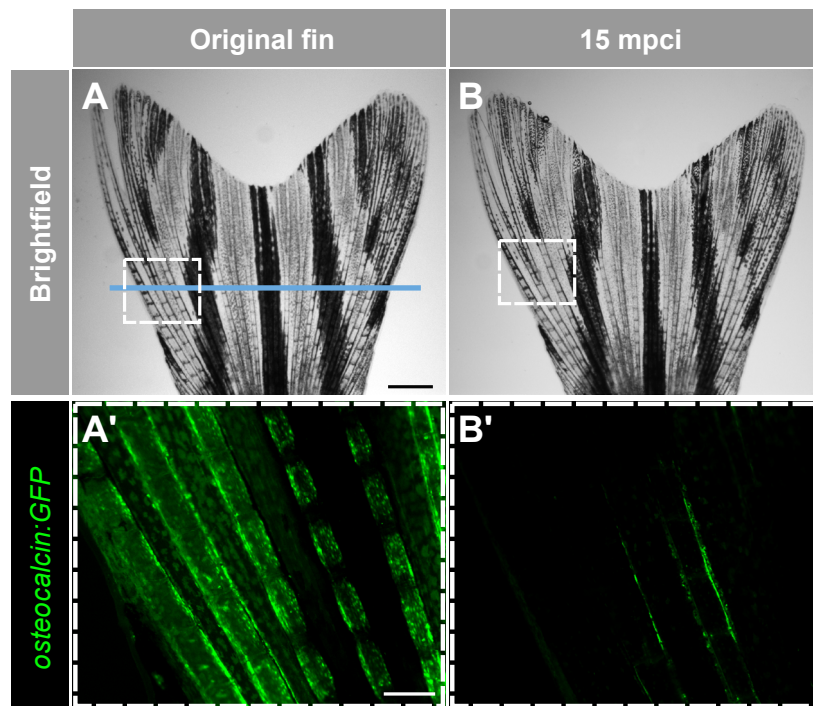
Live-imaging of mature osteoblasts along the bony rays of *Tg(osteocalcin:GFP)* fish.

(A) Brightfield imaging of the same fin before injury and at 15 mpci. Cryoinjury plane is indicated with the blue line. (B) Fluorescence imaging of the framed areas shown in the upper images.

Scale bar in (A), 1 mm; in (B), 250 μ m.
